CIVIL AVIATION DEPARTMENT

CESSNA 402 N402BL

REPORT ON ACCIDENT AT

ON 1 APRIL, 1991

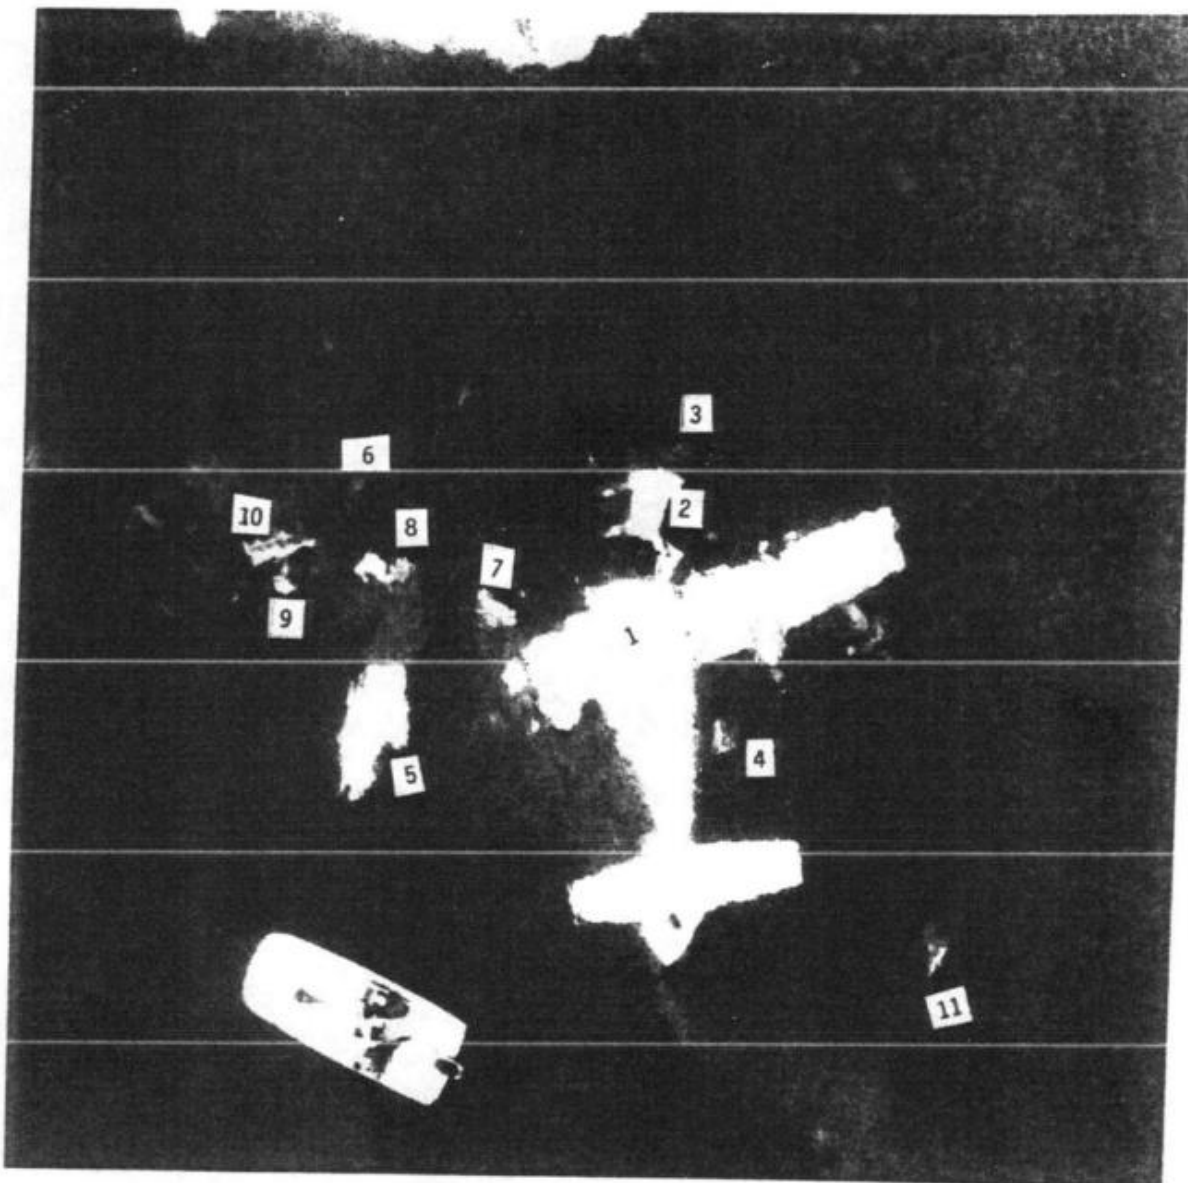
PHOTOGRAPH SHOWING AREA OF WRECKAGE IN THE WATER
(PICTURE TAKEN FROM THE AIR ON 2 APRIL, 1991)

| 1. Fuselage | 6. Battery Box |
| 2. Nose - broken and twisted | 7. Tip Tank - Port |
| 3. Baggage compartment door | 8. Engine with propeller attached |
| 4. Section of skin from belly. | 9. Other engine without the propeller |
| | 11. Starboard Tip Tank |

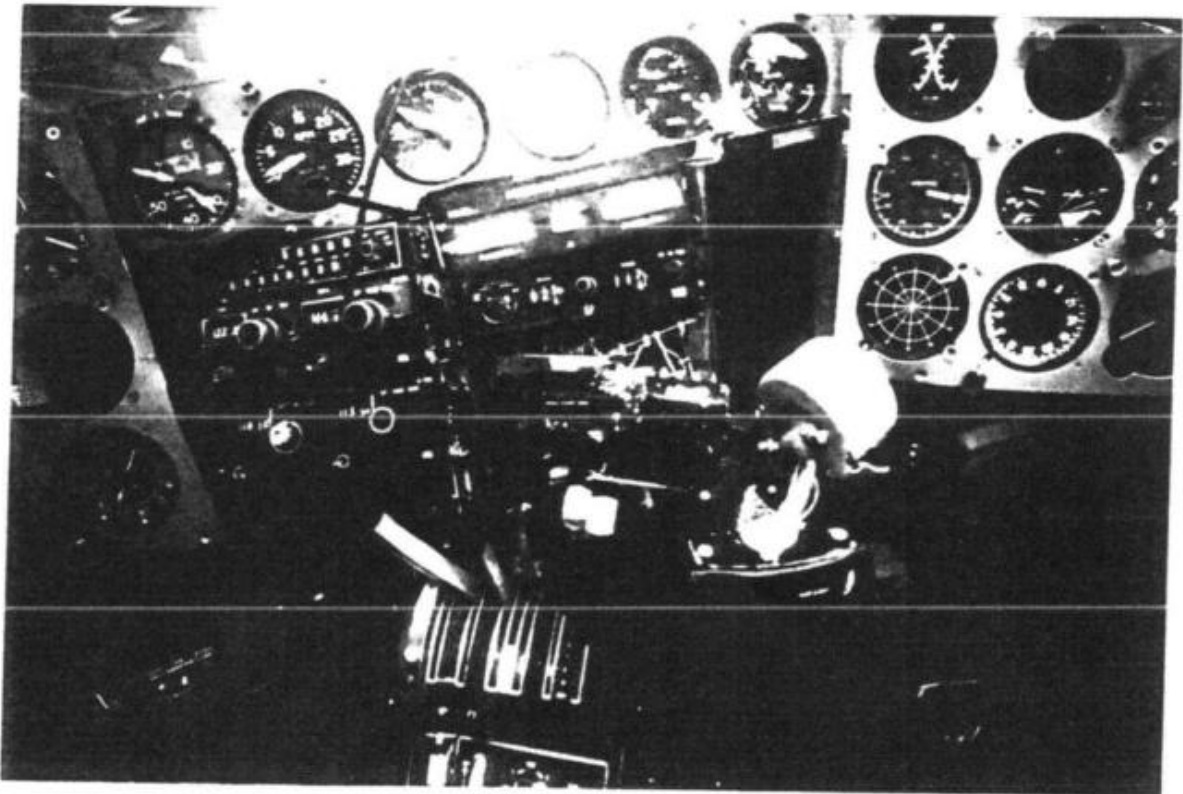
Instrument Panel

15. The instrument panel together with the power quadrant is twisted in a clockwise direction when the aircraft is viewed from the top. The fuselage is broken and detached on the port side and compressed and still attached on the starboard side.

16. Both yokes are broken but attached by wires to their respective column stems.
17. The altimeter settings are: Port altimeter - 30.02; Starboard altimeter - 29.92. The altimeter setting obtained from the Belize Weather Bureau for 011500 April 1991 local was 30.08.
