CIVIL AVIATION DEPARTMENT

**CESSNA 207A V3-HFD
REPORT ON ACCIDENT AT
BELAMA PHASE II EXTENSION, BELIZE CITY,
ON 23RD JULY, 1997.**

AIRCRAFT ACCIDENT REPORT : # 1/97
 OPERATOR : TROPIC AIR LIMITED
 AIRCRAFT : CESSNA
 : MODEL 207A
 : SERIAL NUMBER 20700676
 NATIONALITY AND REGISTRATION MARKS : V3-HFD
 PLACE AND DATE OF ACCIDENT : BELAMA PHASE II
 EXTENSION, BELIZE CITY.
 23rd JULY, 1997.

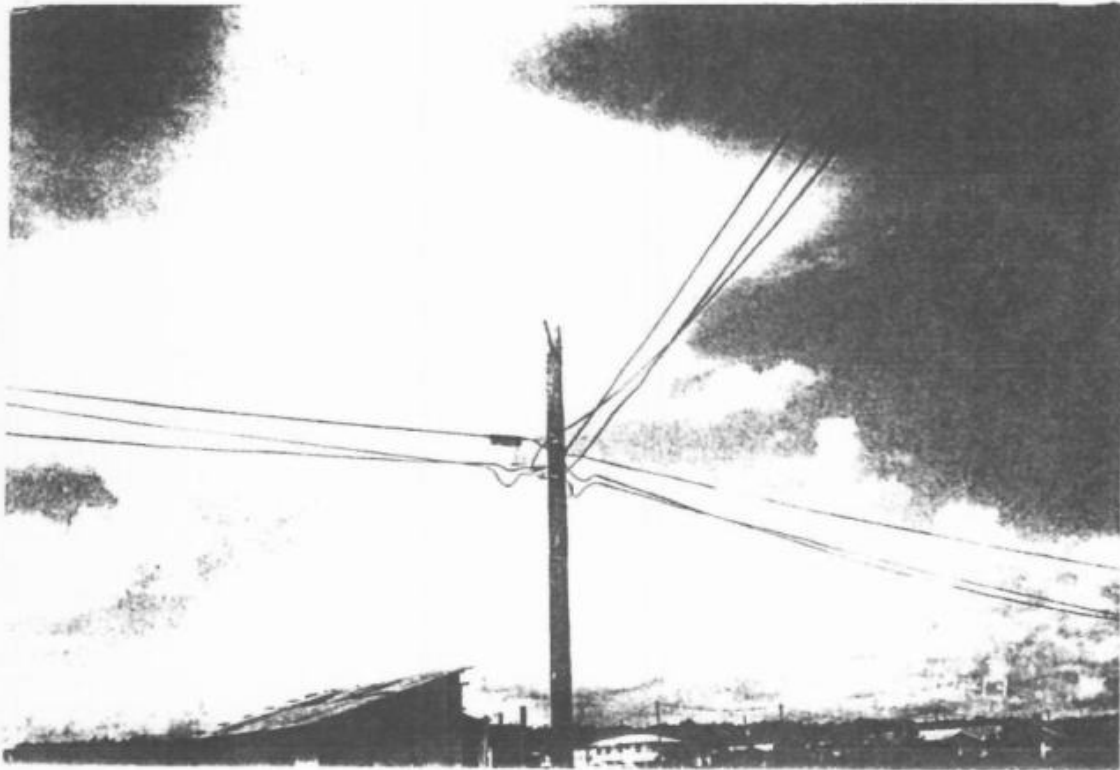
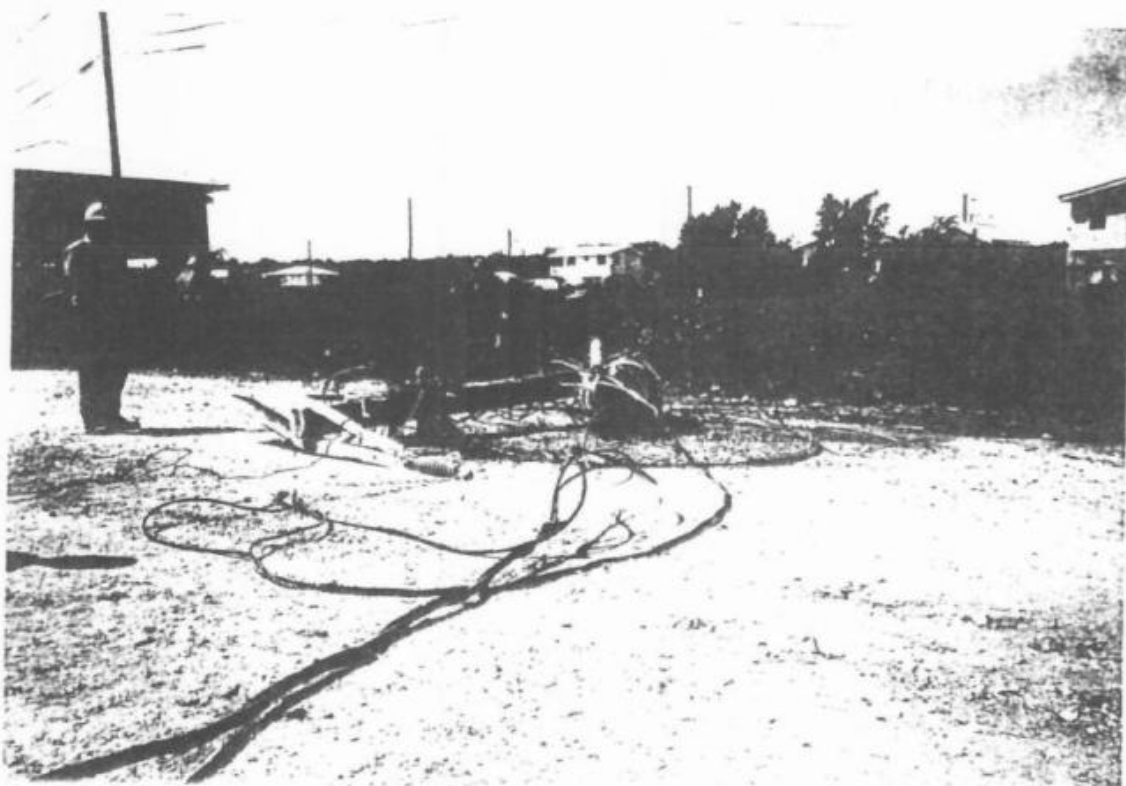
Snapped lamp post and broken electrical cables
caused by aircraft

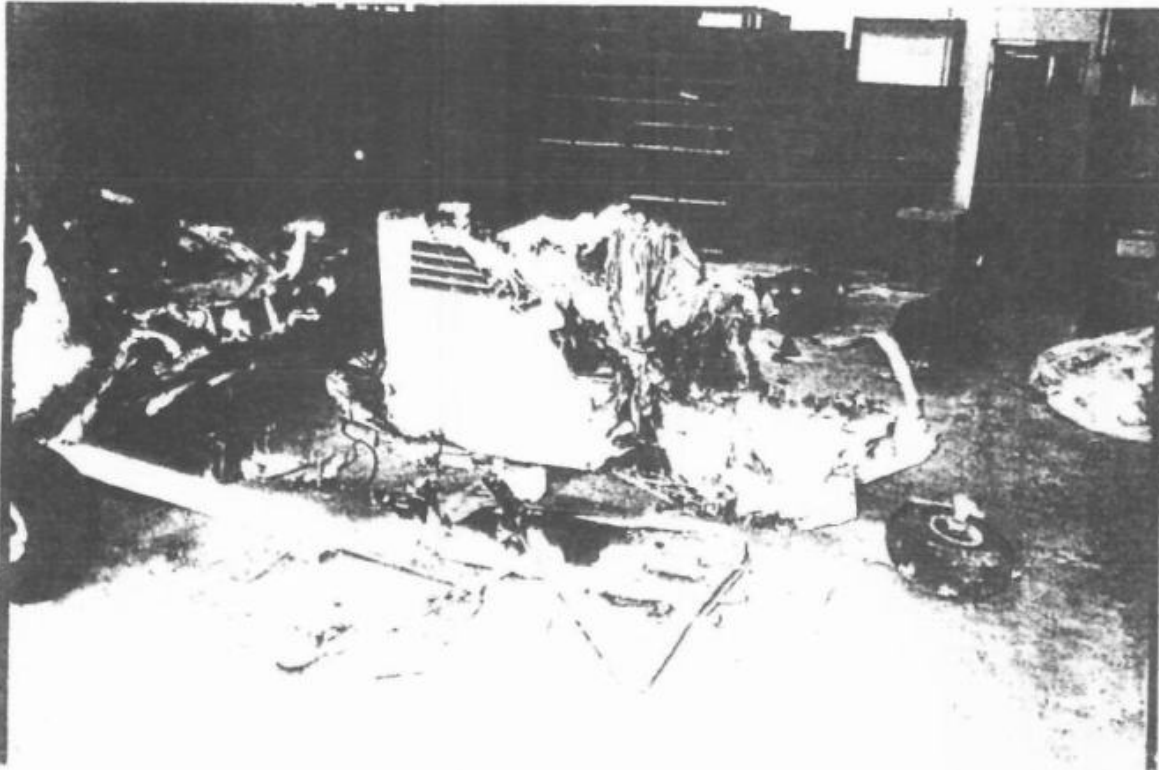
Sorting of Aircraft
Wreckage - BDF Hangar

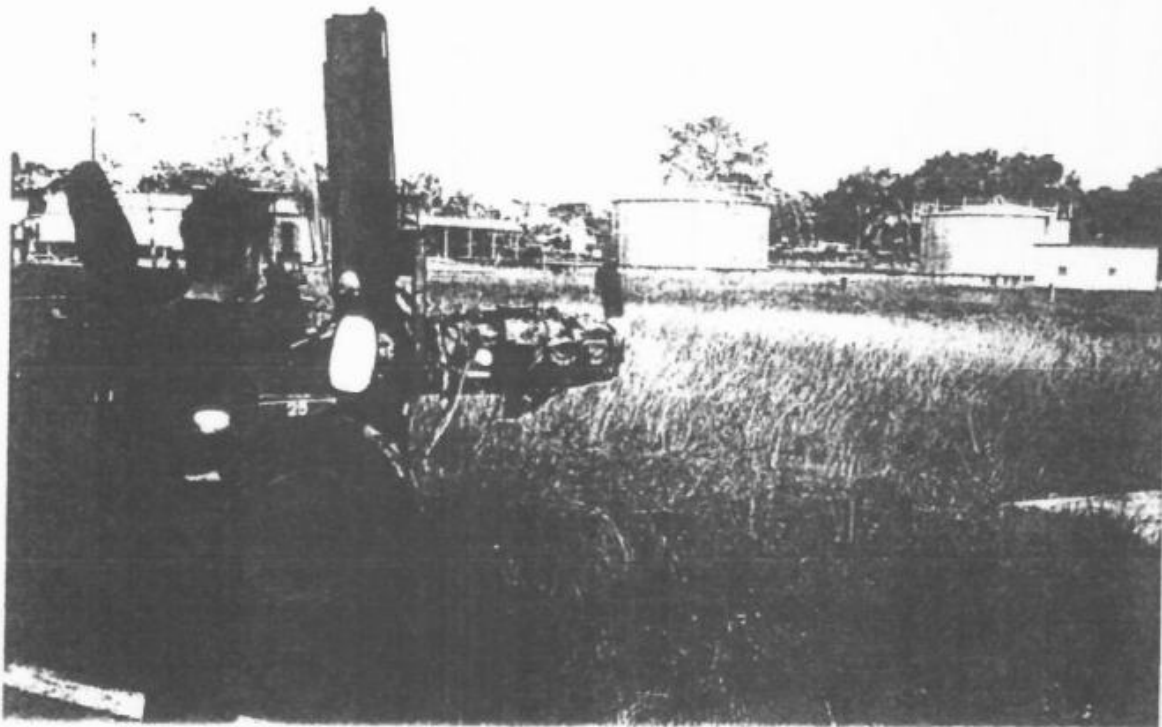
In conclusion, this engine exhibited normal operational signatures throughout. All internal components appeared well lubricated. The fuel system components flowed at or very near TCM specifications. This engine did not exhibit any condition that would have caused an operational problem.

Test running of aircraft engine witnessed by
designated Civil Aviation Department Engineer

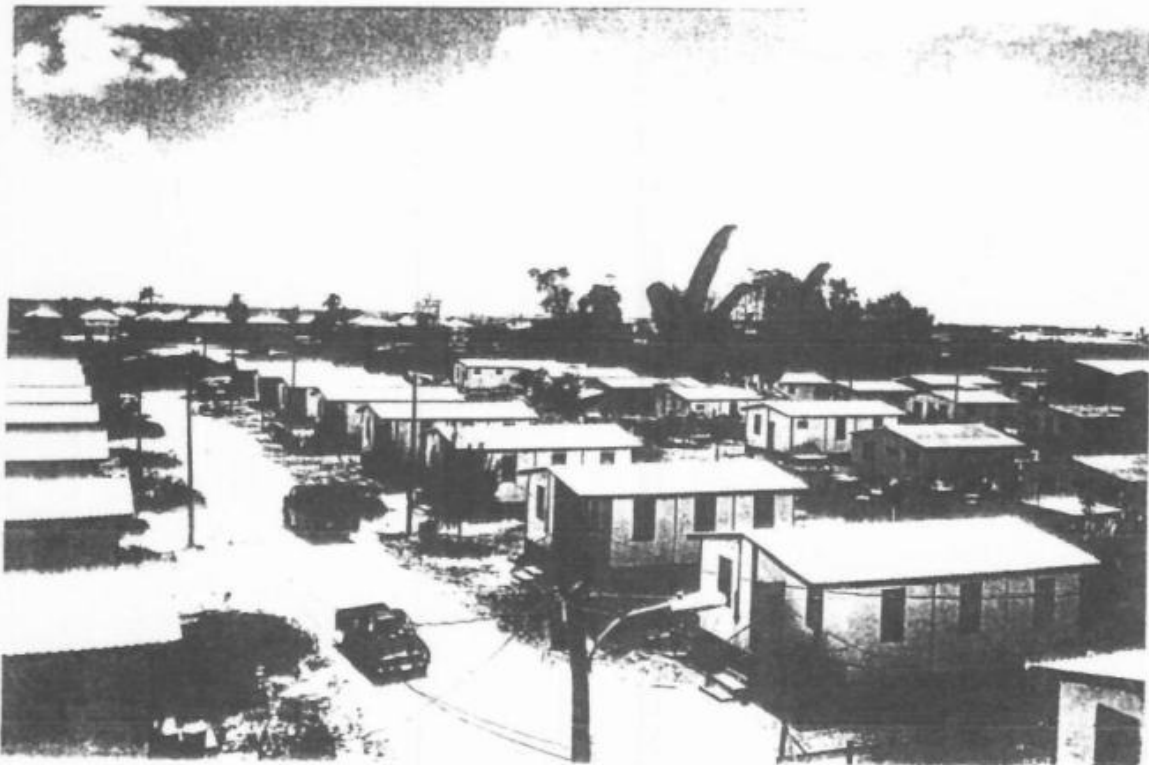
Arrows indicating Crash Site in Residential Area
(Belama Phase II)

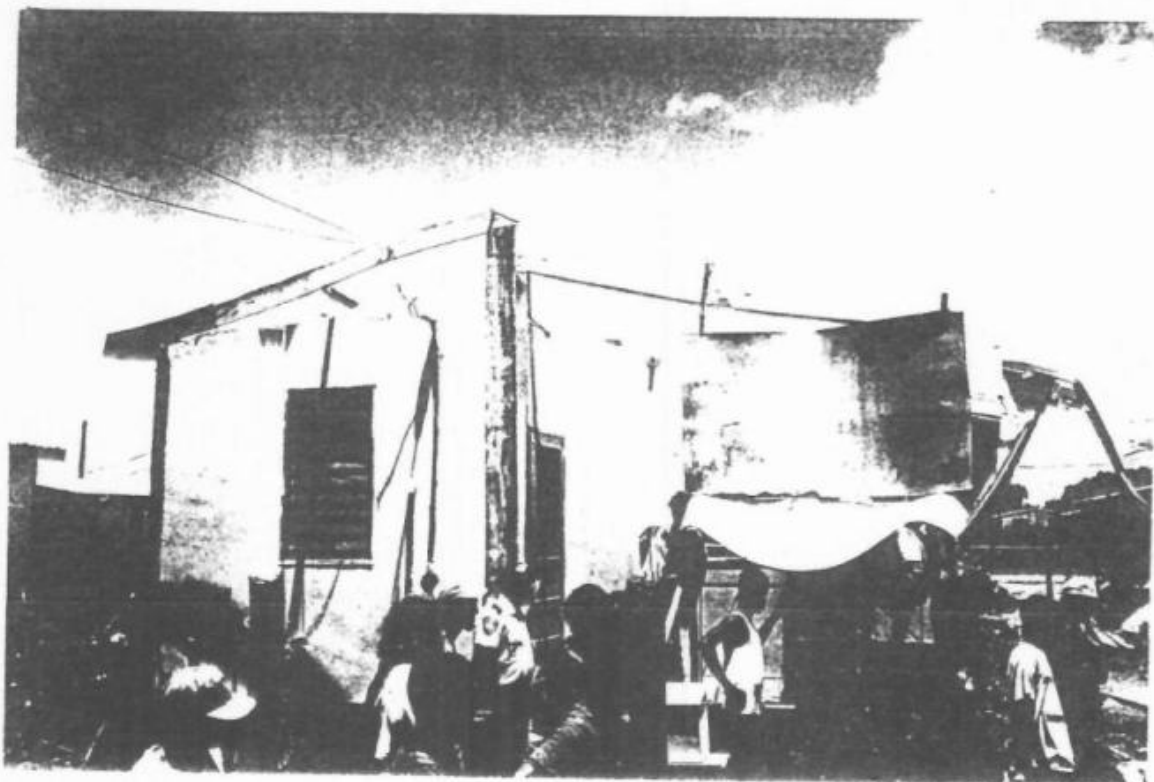
The zinc roof of one house was partially torn off and the house (Lot #312) into which the aircraft crashed was extensively damaged by the impact and the fire that ensued immediately after the crash.

House roofing destroyed by aircraft
vertical stabilizer (tail area)

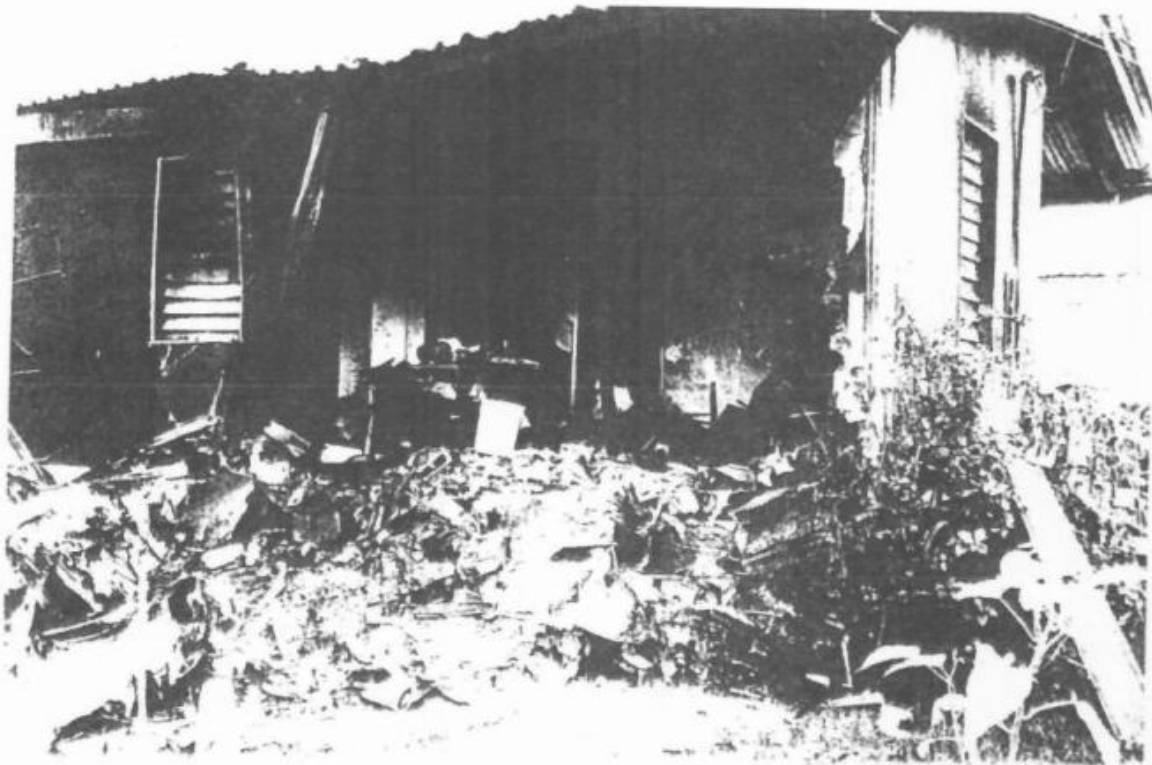
The aircraft crashed on an upside position into a concrete wall and zinc roof house which was located at approximately 300-400 feet from the first point of contact of the aircraft. The western side of the house was partially knocked down when the aircraft hit it. The interior of the house was damaged by fire which ensued immediately after the aircraft crashed and its zinc roofing was partially damaged. The aircraft was damaged by fire except for sections of the engine's frame, tail, landing gears and instrument panel. Only the engine and propeller were not destroyed. The blades of the propeller were bent on impact but were found attached to the engine.

General view of aircraft wreckage at crash site

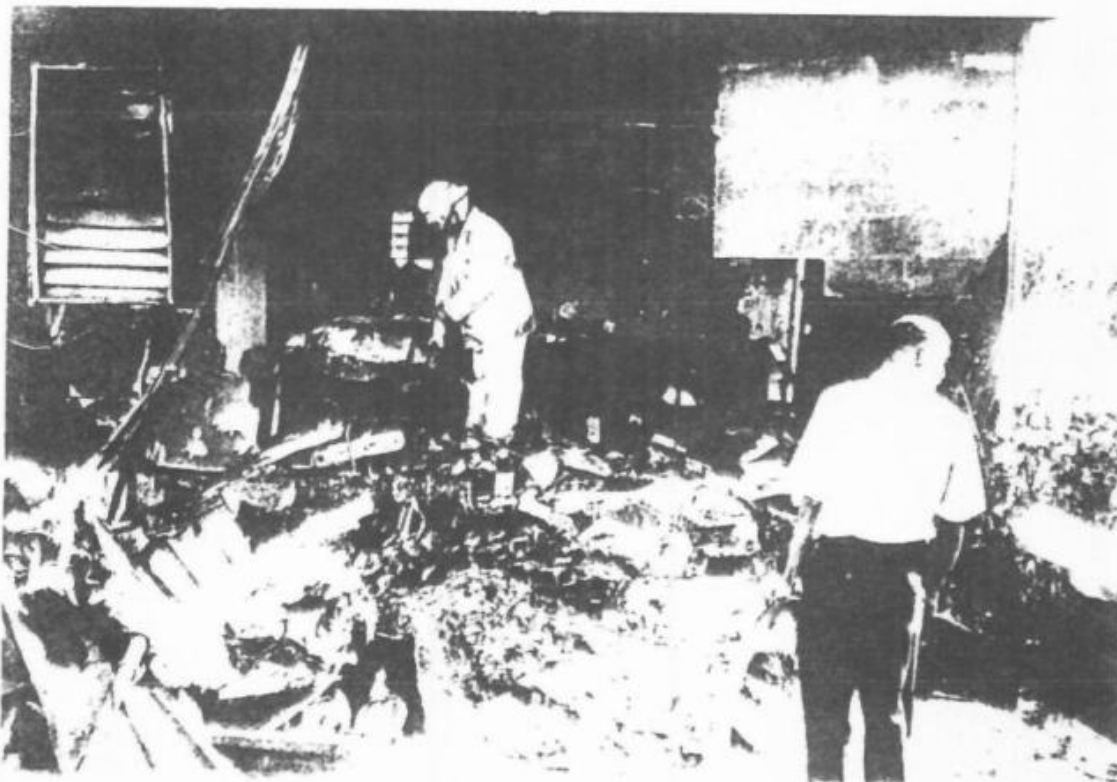
House wall destroyed by aircraft impact
